# THE IMPACT

of the Russian Drone Attack  
on the Chornobyl New Safe Confinement

# **Initial Assessment of the Impact of the Russian Drone Attack on the Chornobyl New Safe Confinement**

**Eric Schmieman,**

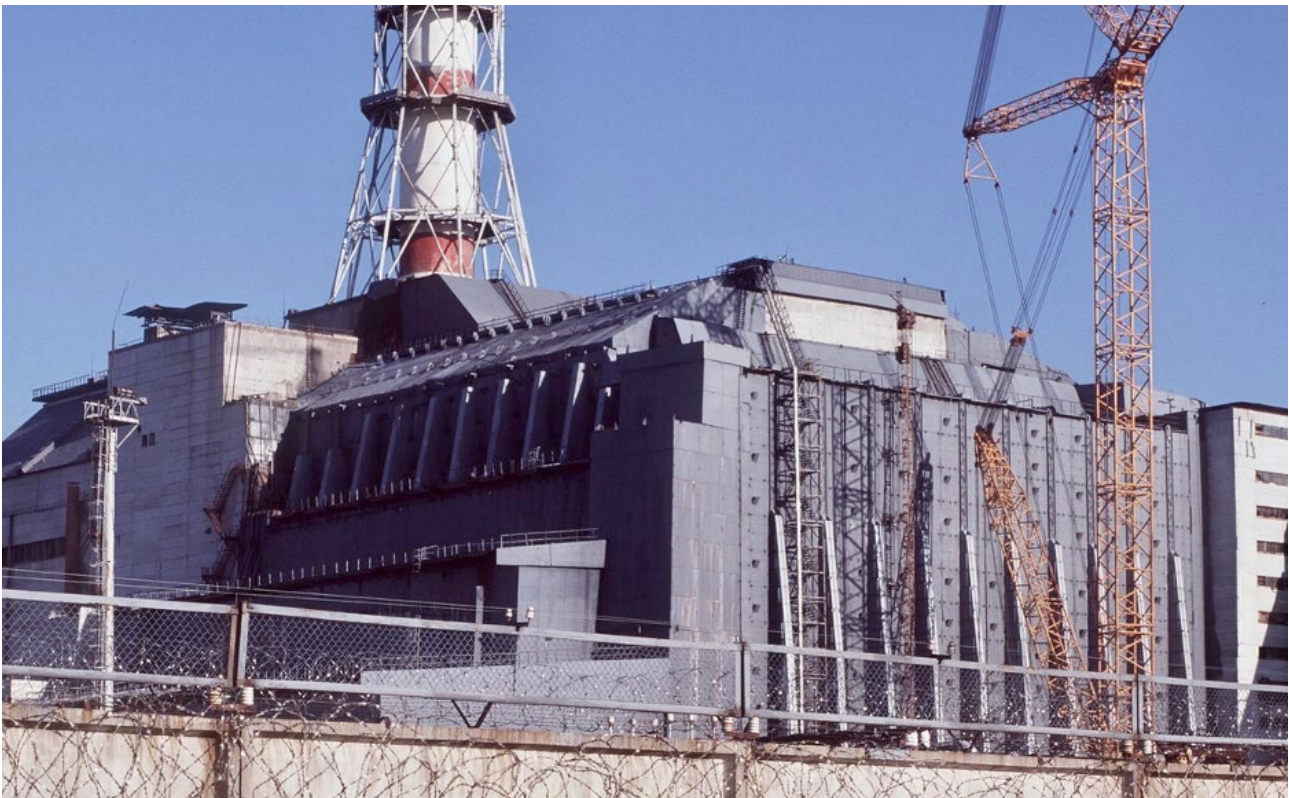
Shelter Object/Sarcophagus at Chernobyl unit 4, 1996 Credit Clive Shirley/Greenpeace

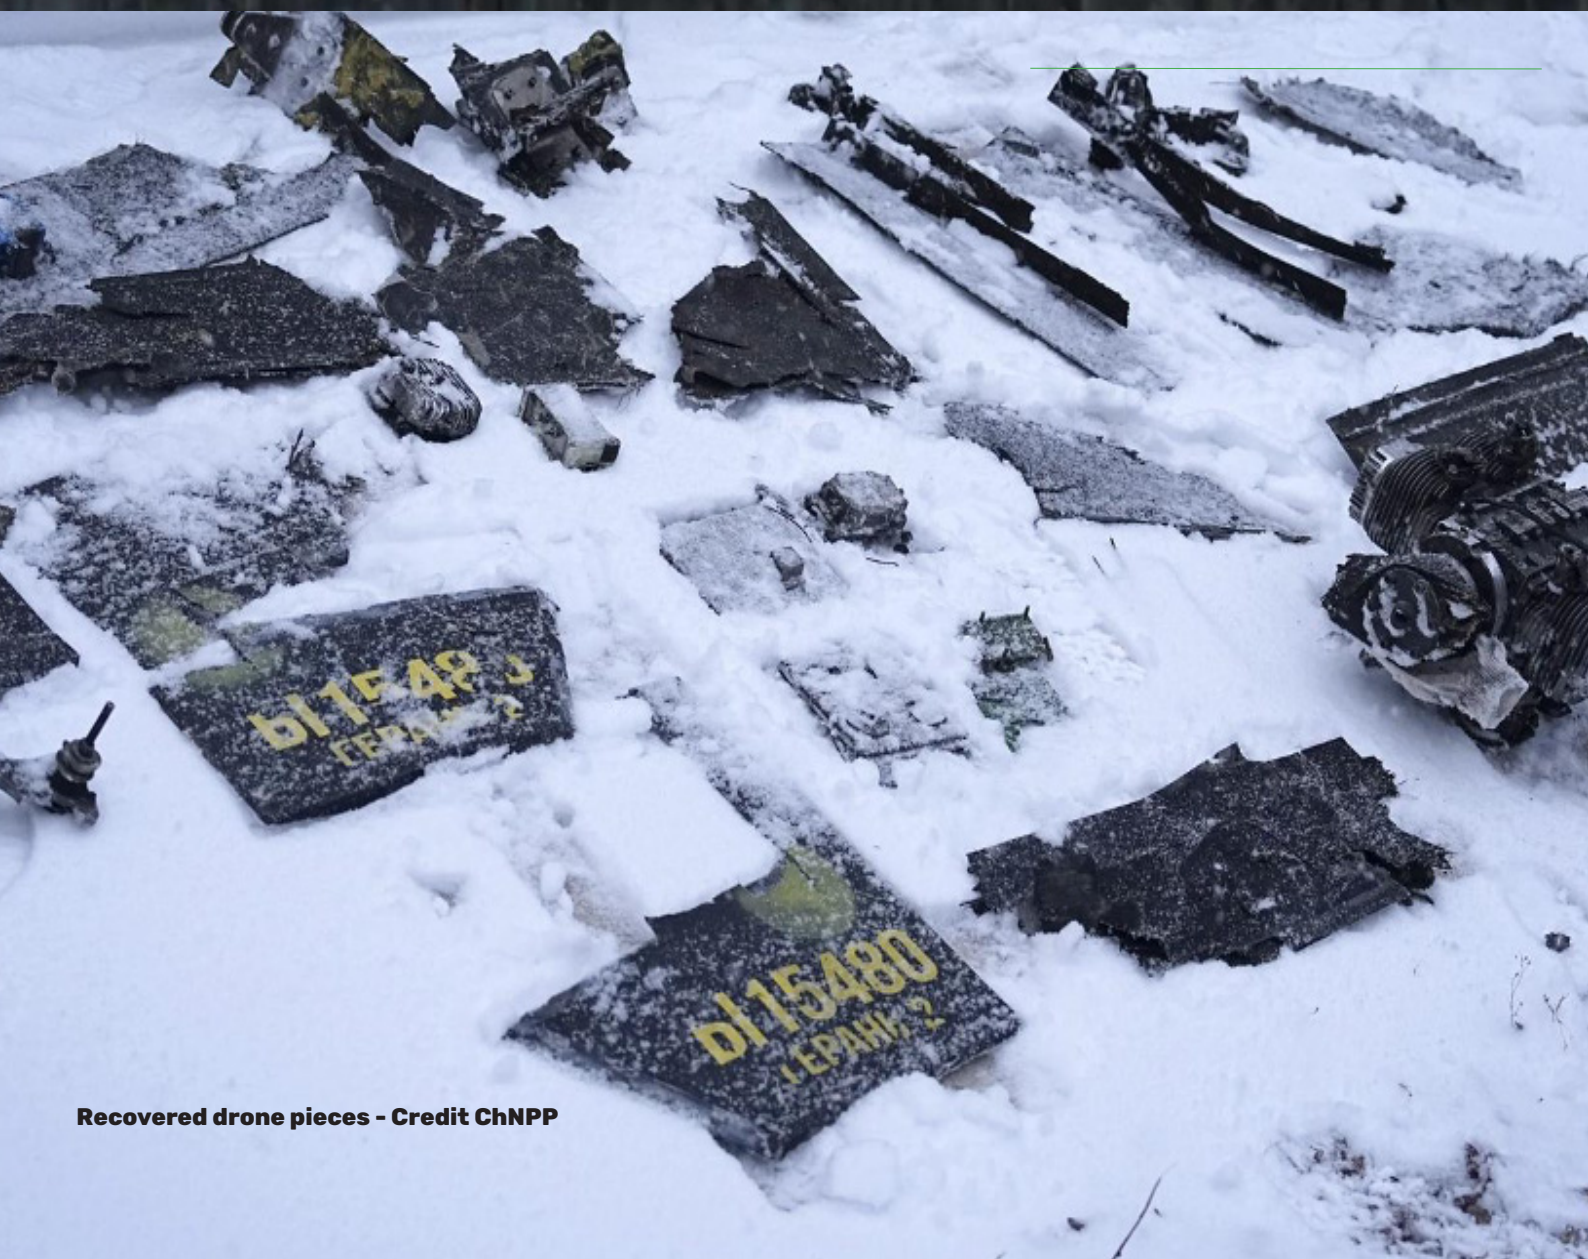
Recovered drone pieces - Credit ChNPP

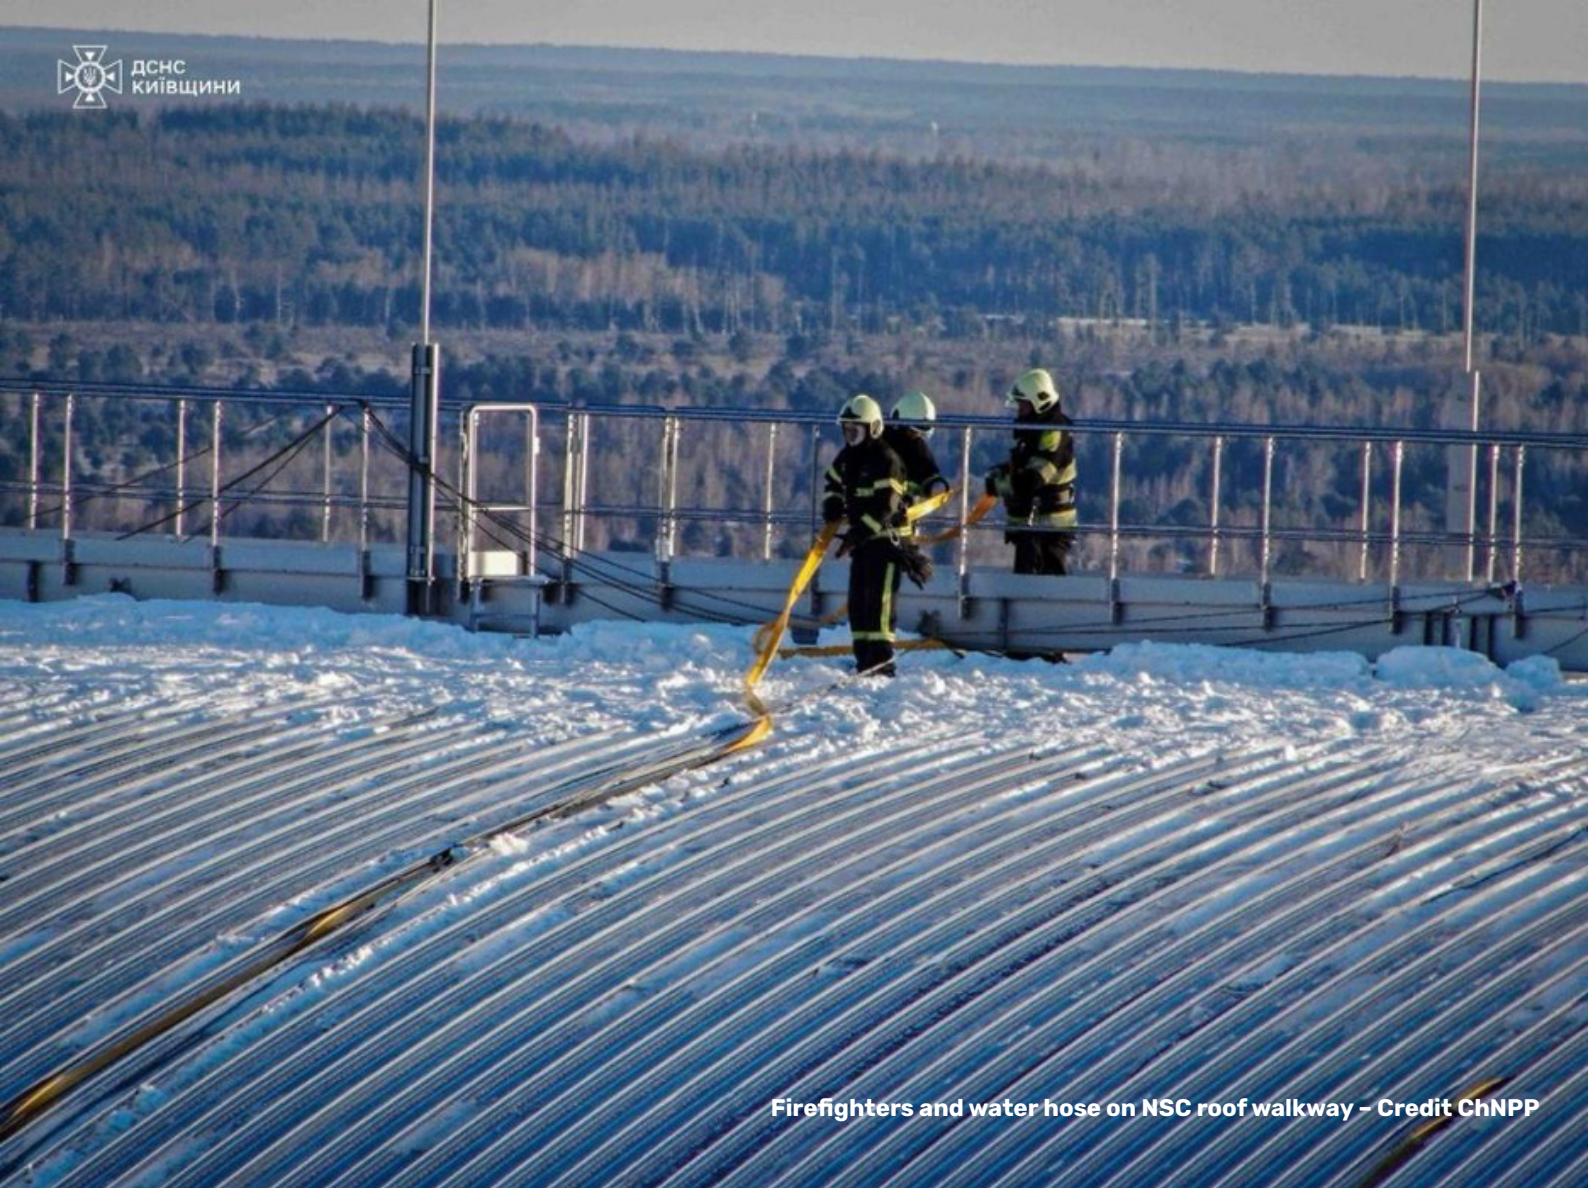
Firefighters and water hose on NSC roof walkway – Credit ChNPP
